NATIONAL PROGRAM FOR INSPECTION OF NON-FEDERAL DAMS
LYNDE BROOK RESERVOIR. (U) CORPS OF ENGINEERS WALTHAM
MA NEW ENGLAND DIV MAY 80

LYNDE BROOK RESERVOIR DAM

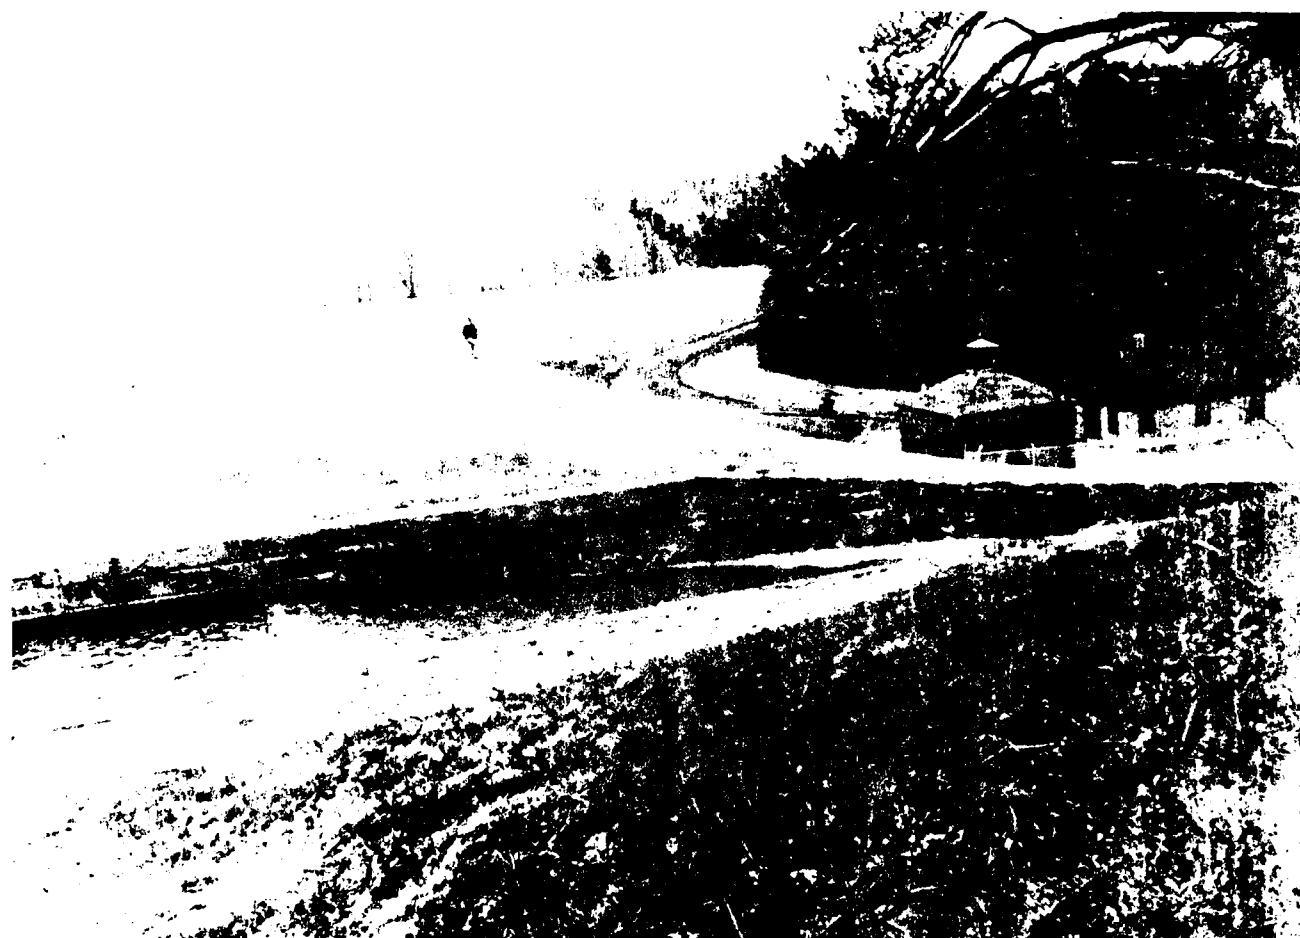
OVERVIEW OF DAM FROM RIGHT ABUTMENT

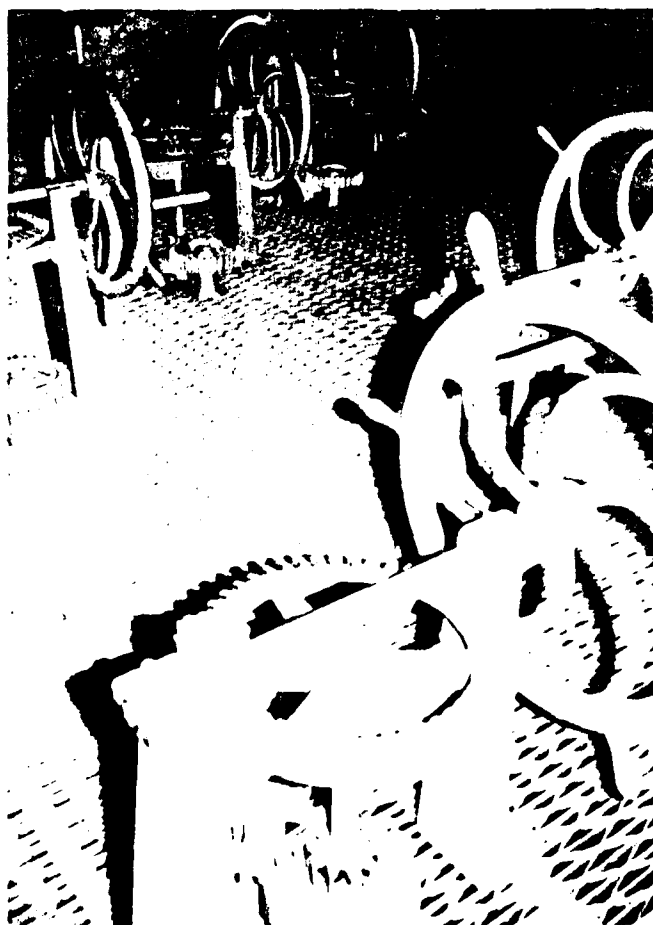
13. Manual operating mechanisms in first floor of gate house at downstream toe of dam.

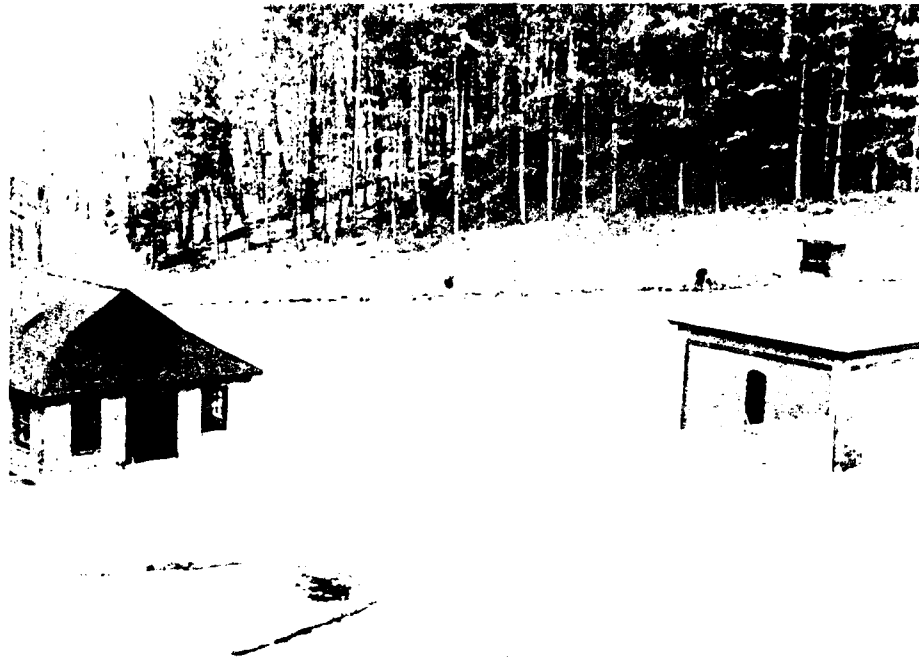
11. Outlet gate house on right and chlorination building on left at downstream toe of dam.

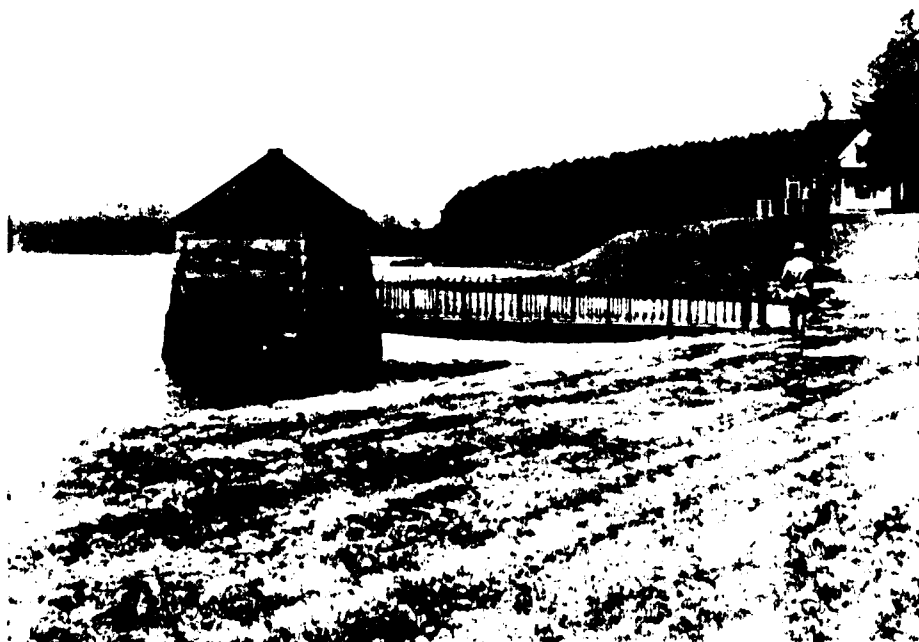
12. Gate house at north end of East Dam.

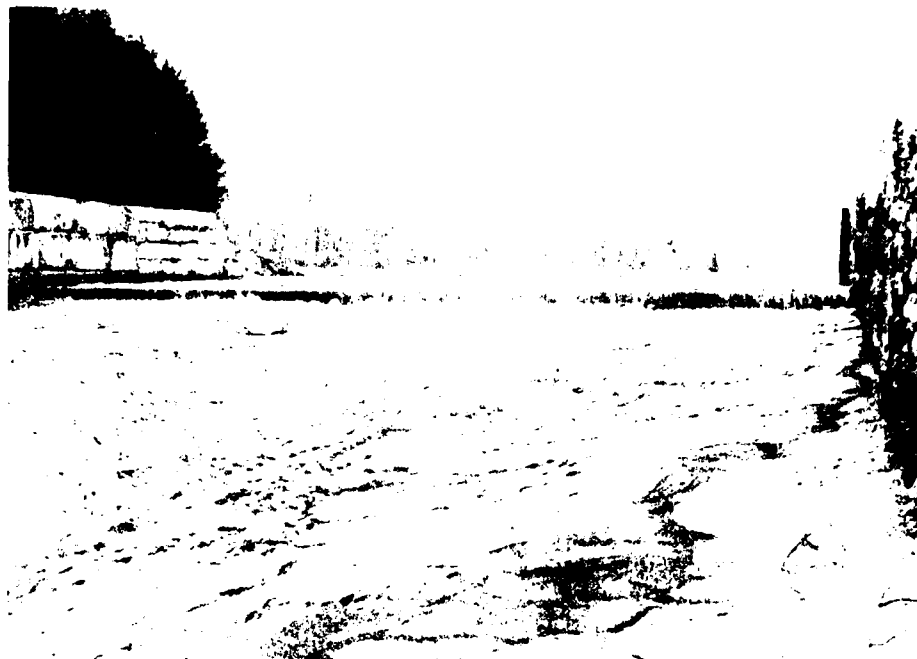
9. Spillway training walls and angle iron sill

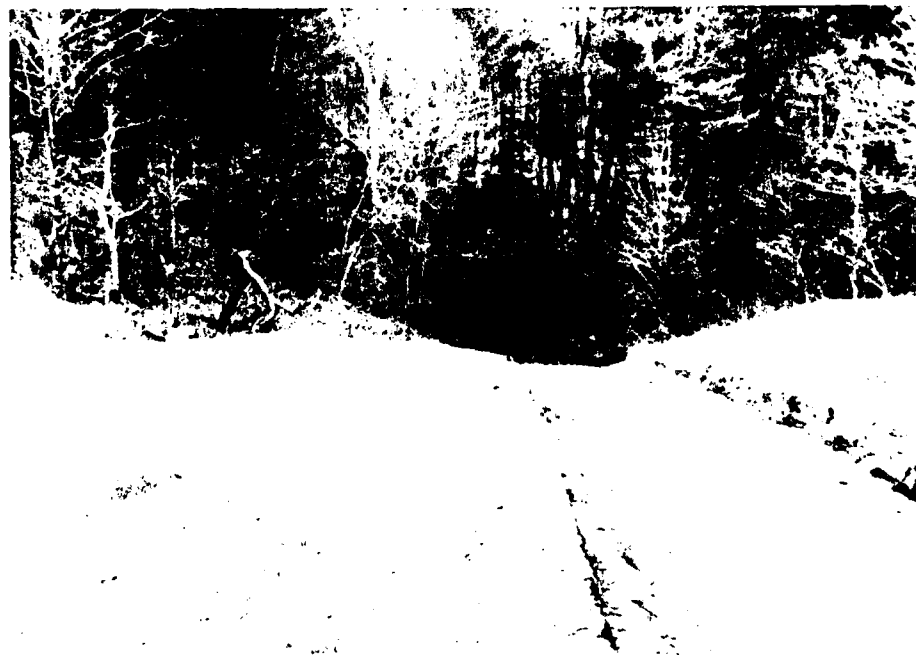
10. Downstream spillway channel

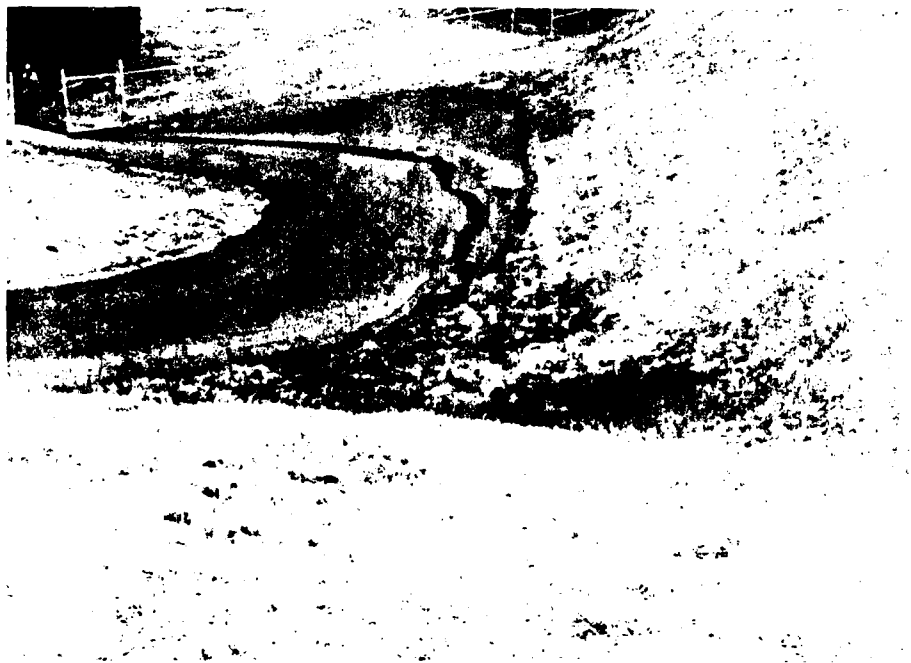
There are no design calculations, as-built drawings or other data which would permit the preparation of structural stability computations. The dam is now stable and is in good condition. The only deficiency that should be monitored is the minor seepage in two locations at the downstream toe of the dam.

5. Seepage at downstream toe of dam

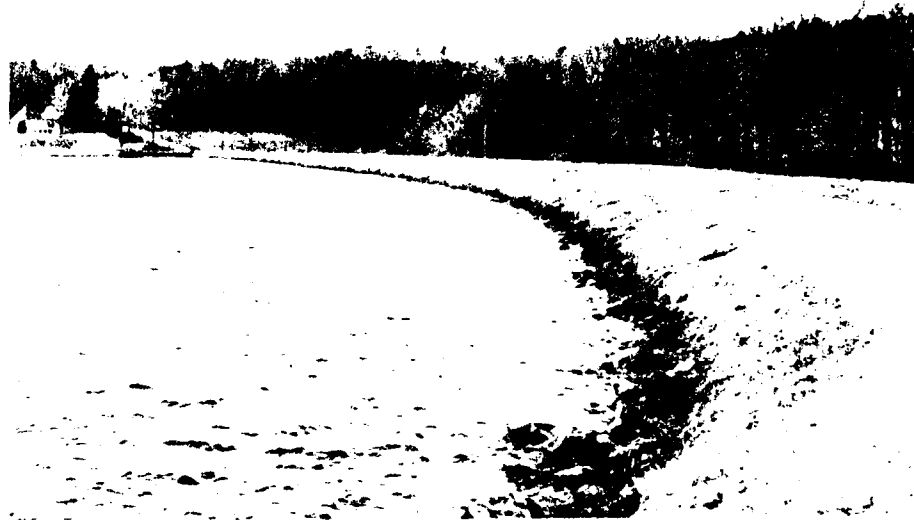
Dike. The dike is also an earth embankment with a masonry core wall. It is about 1,050 ft. long, 14.5 ft. high and has a crest width of about 42 ft. The crest and $1\frac{2}{3}$ horizontal to 1 vertical downstream slope are grass covered and well maintained. The upstream slope is of random rock riprap. At the time of the inspection there was no evidence of seepage along the dike. In general the dike is in excellent condition (see Appendix C, Photo Nos. 3 & 4).

3. Upstream slope of East Dike

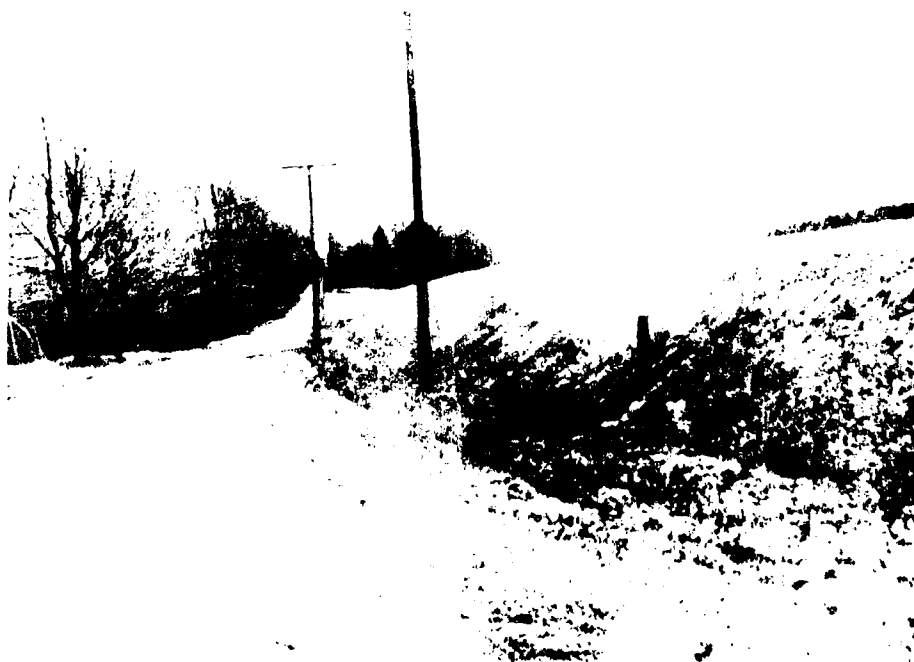
4. Downstream slope of East Dike

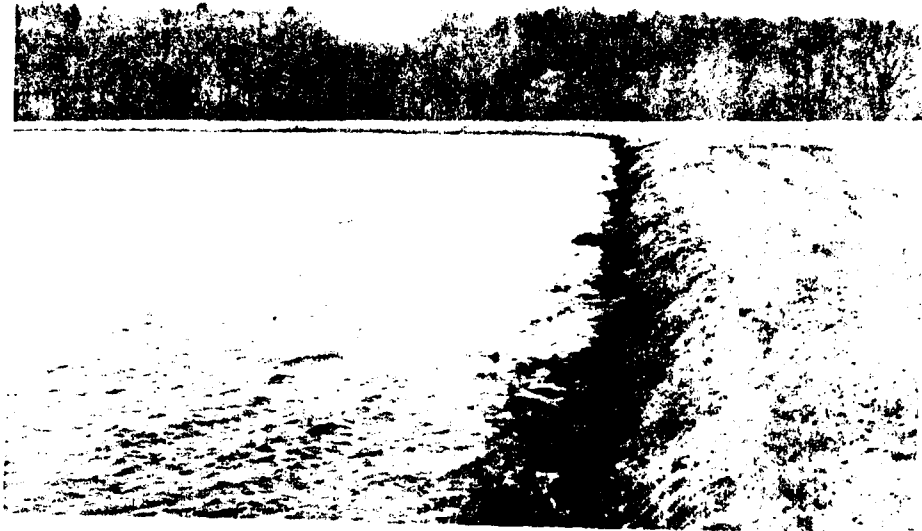
1. Upstream slope of dam
